CALSPAN ON-SITE AIR BAG DEPLOYMENT INVESTIGATION

CALSPAN CASE NO. 91-3

**VEHICLE - 1990 GEO STORM GSi
LOCATION [REDACTED], LOUISIANA
ACCIDENT DATE - [REDACTED] 1990**

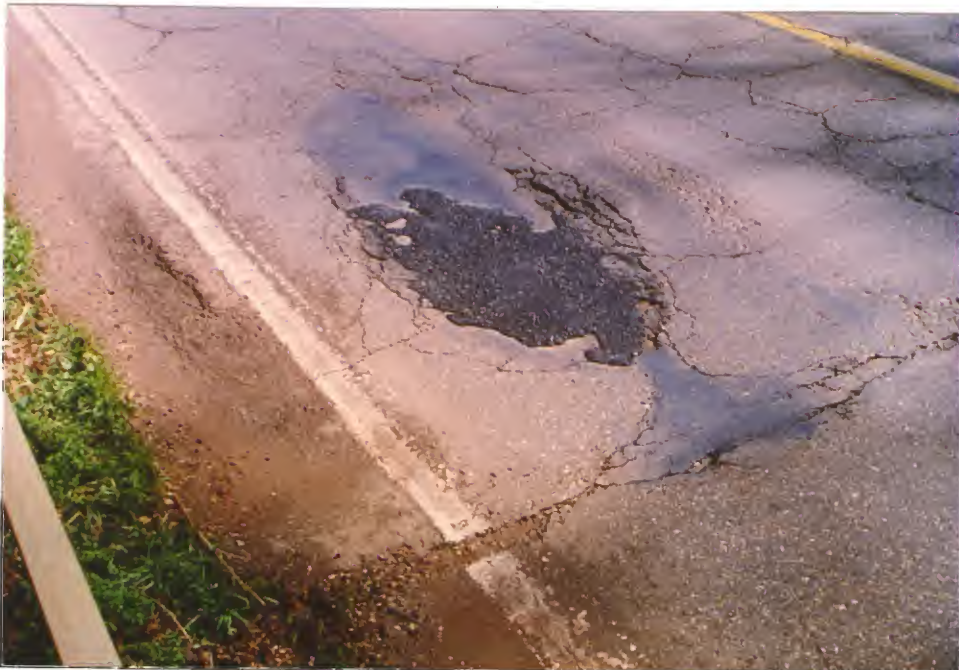
Pavement Depression

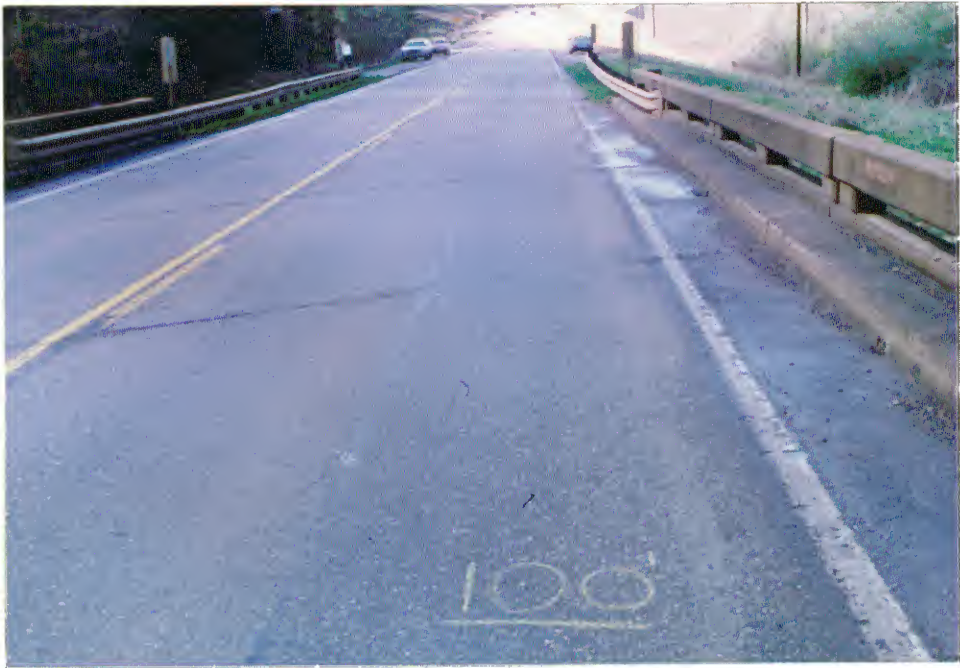
Barrier Curb Struck by Right Rear Tire and Wheel

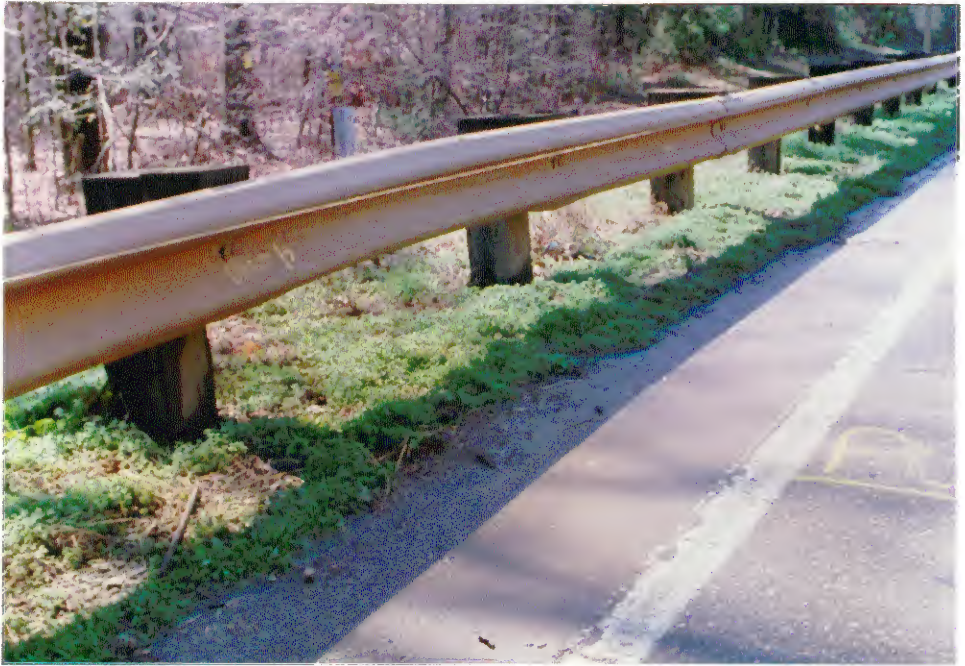
Struck Guardrail

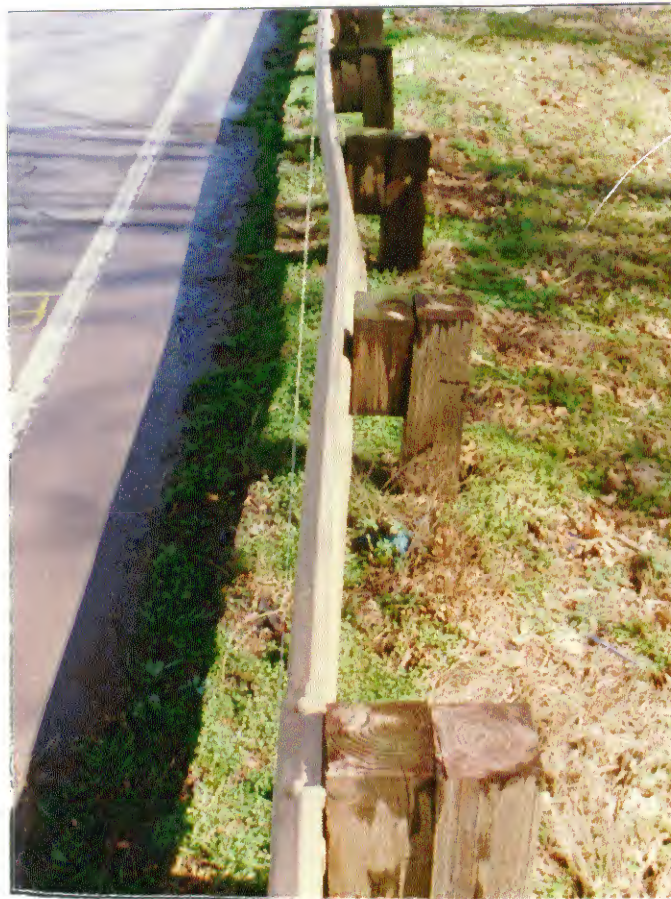
Longitudinal View Showing Deflection to W-Beam Guardrail

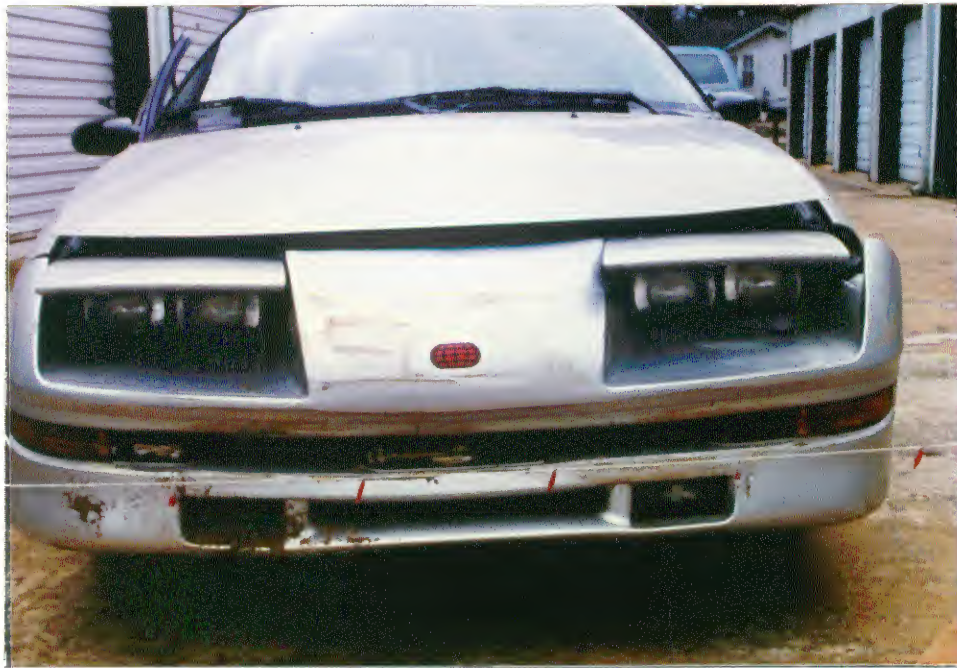
Frontal View of the Geo Storm

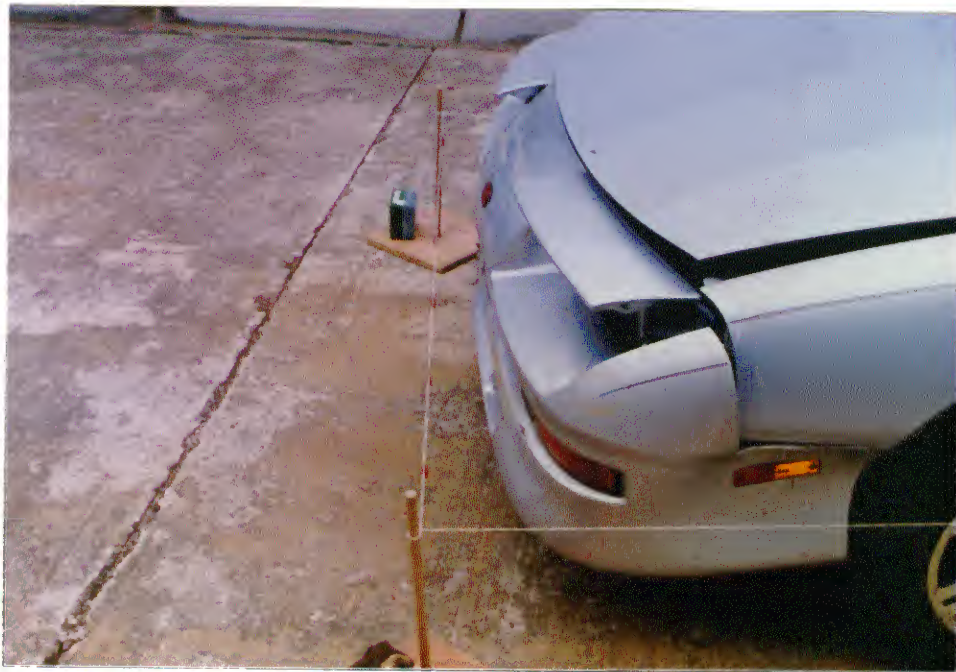
Perpendicular View Showing the Extent of Crush

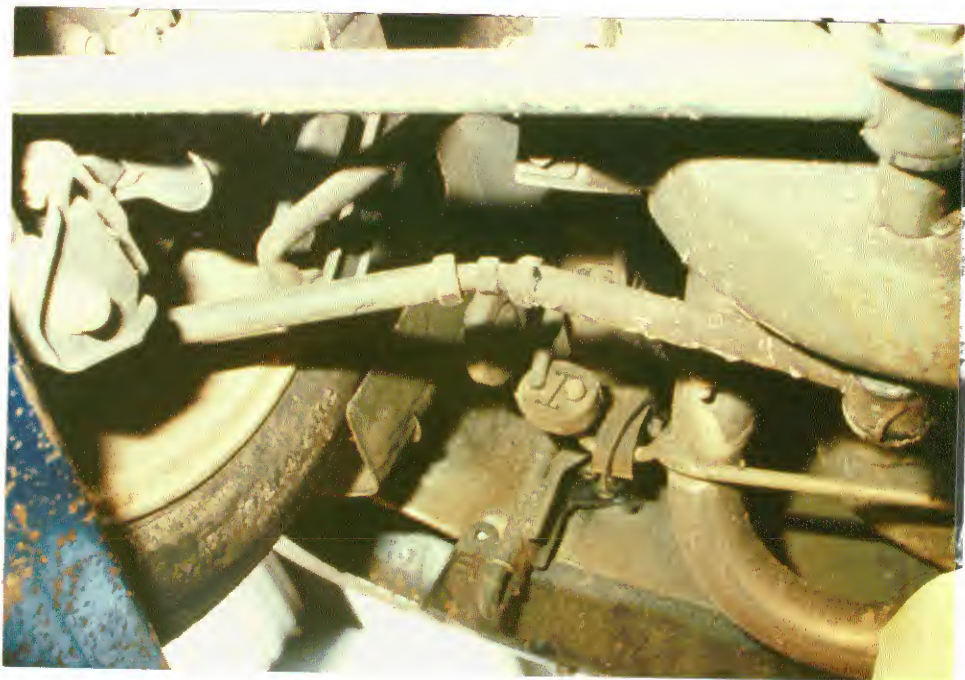
Toe Out Adjustment Rod Displacement

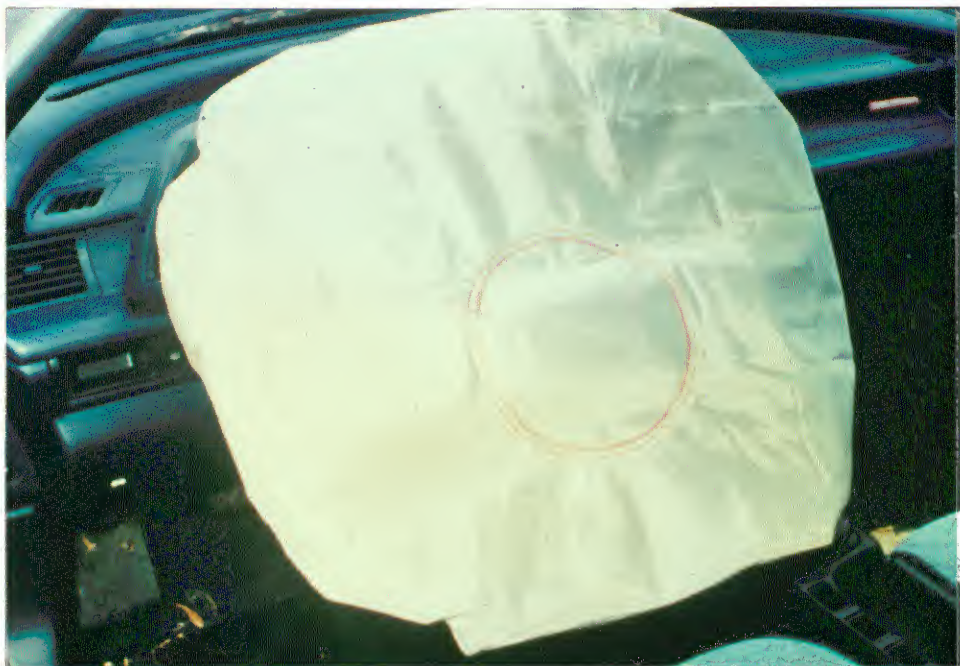
Overall Interior View

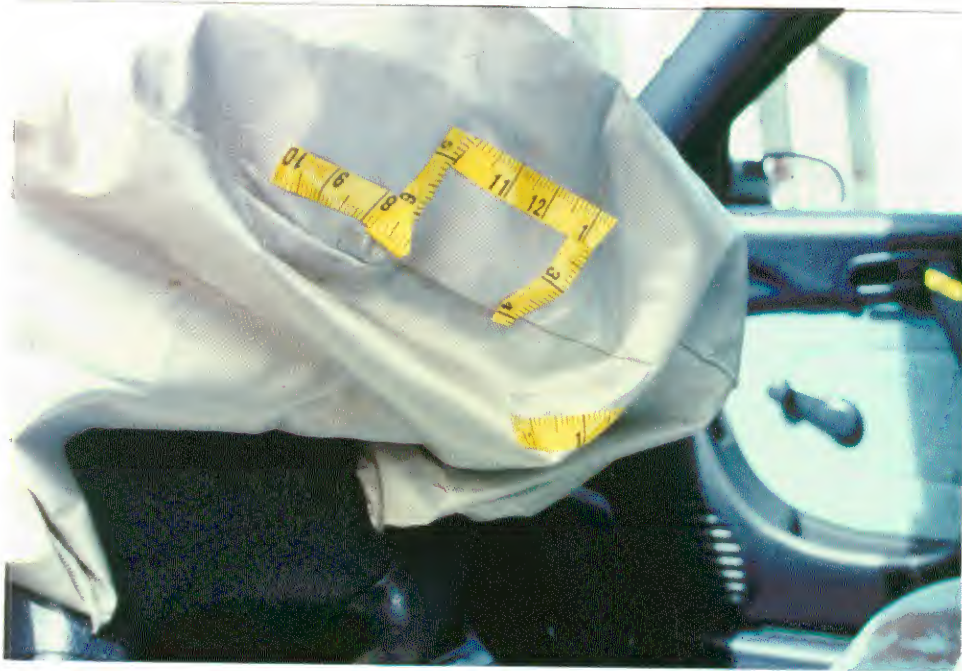
Deployed Driver Air Bag

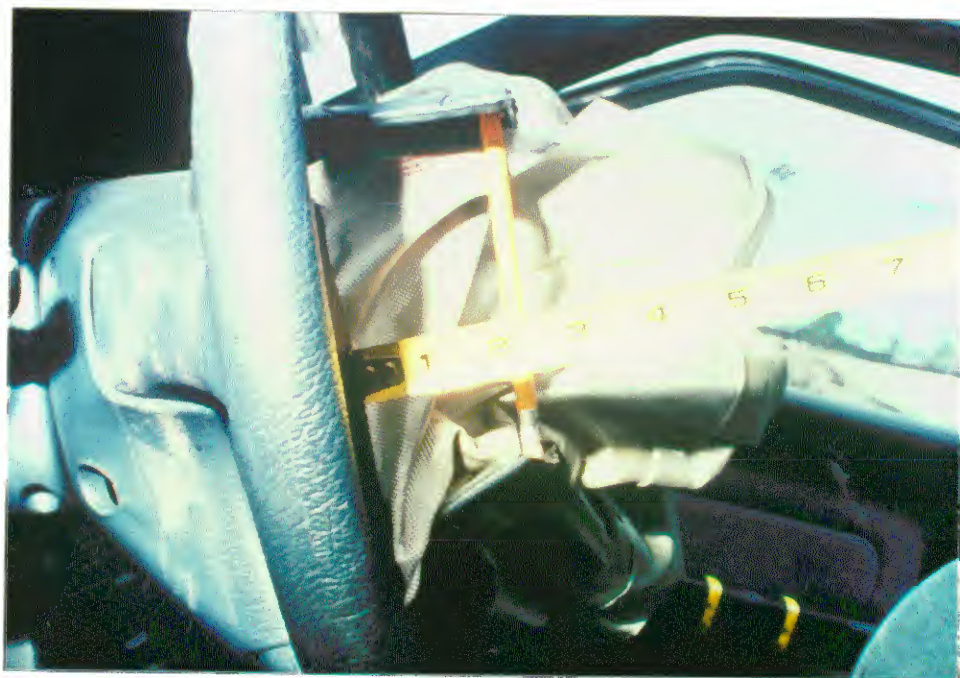
Make-up Transfers on the Peripheral Surface of the Bag

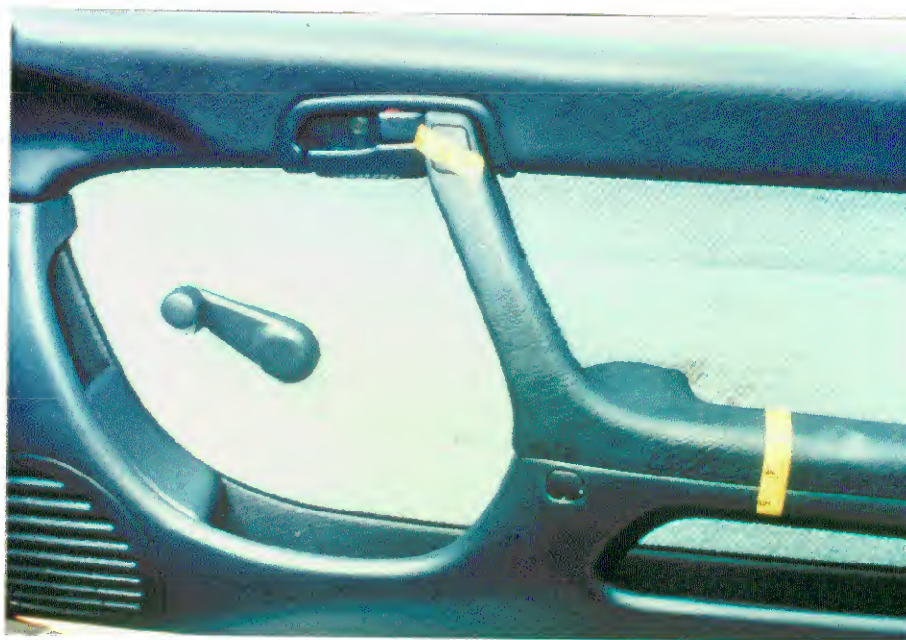
Trajectory of Driver Toward Right Front Door

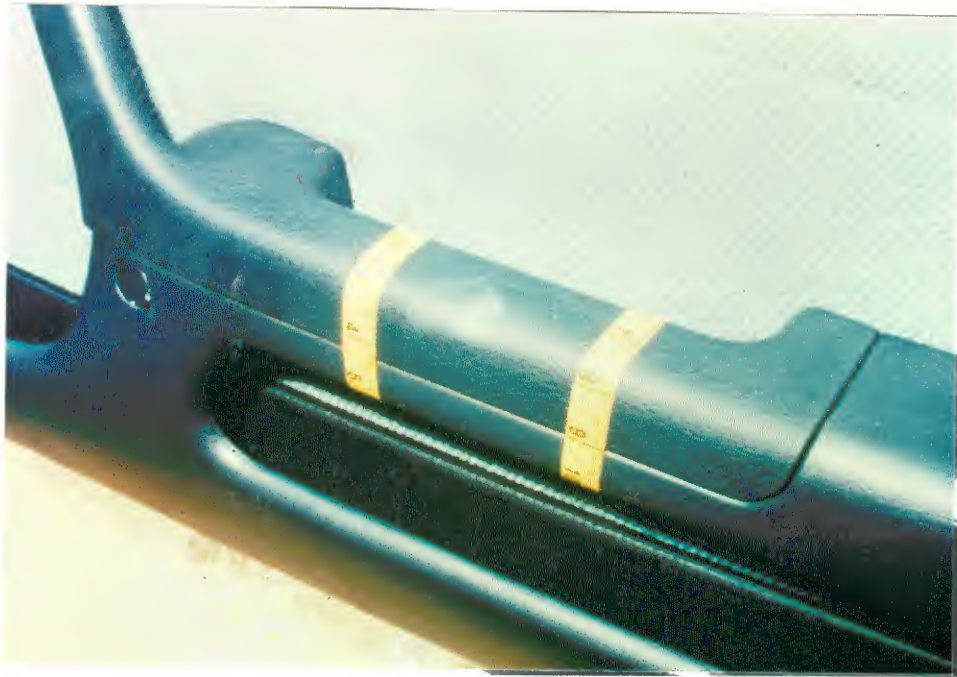
Facial Contact to the Right Door Pull Handle

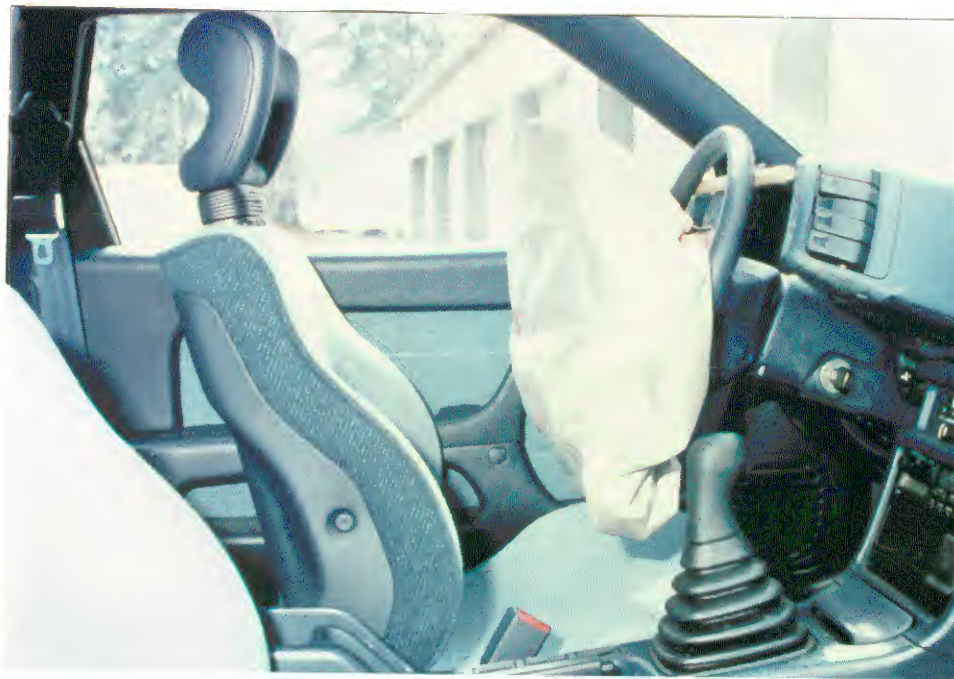
Final Rest Position of Driver's Head

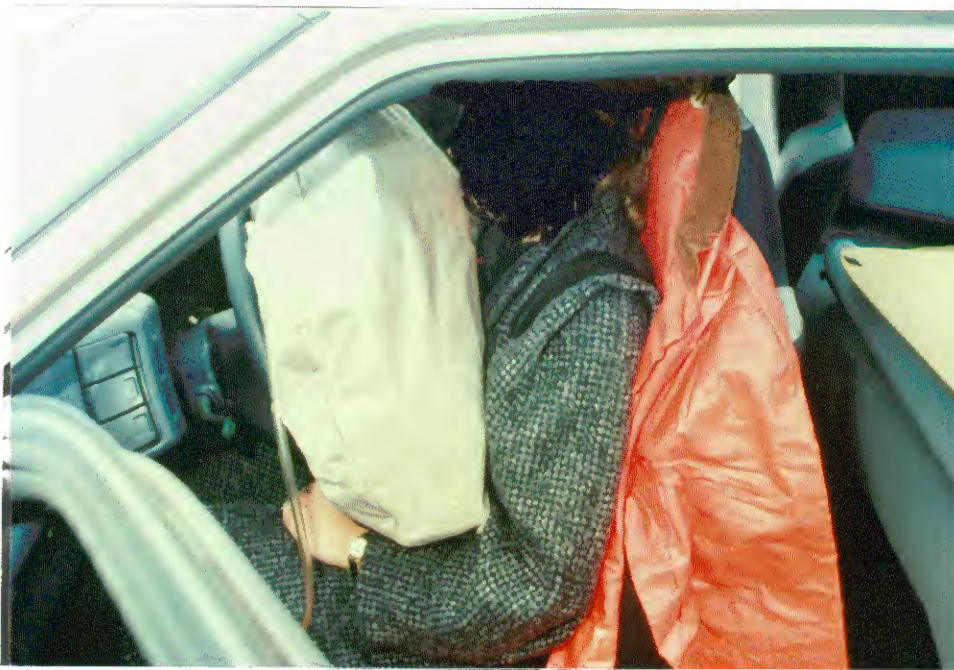
Perpendicular View of Driver's Seat Position

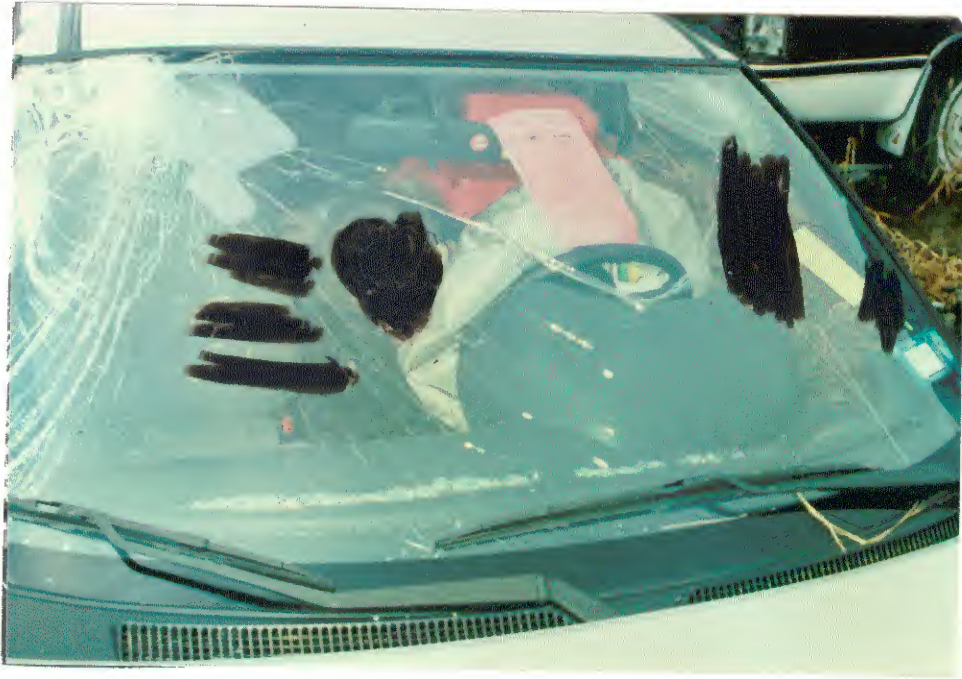
Simulation of Driver Position

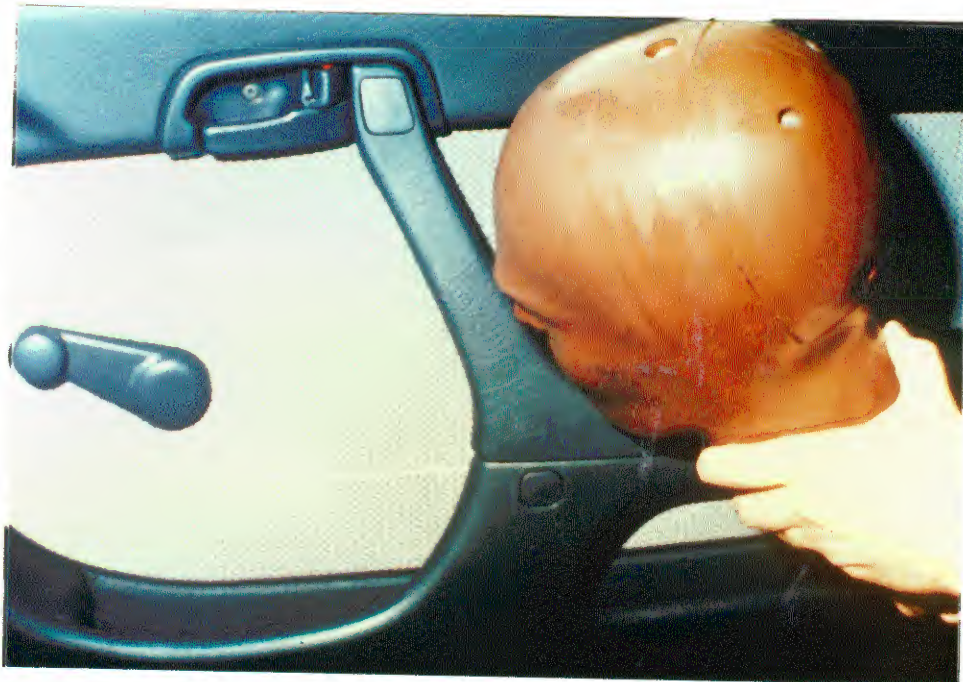
Simulation of Facial/Head Impact to the Right Door Pull Handle

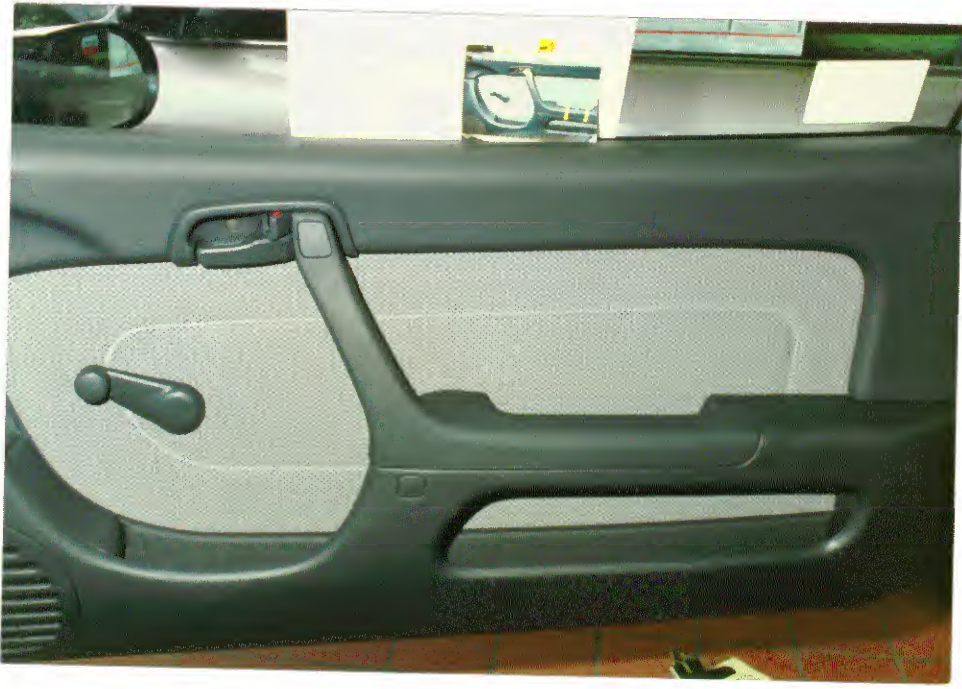
Hybrid III Head Form Simulated Contact With Right Door Pull Handle
